Tundra Treatment Guidelines

A Manual for Treating Oil and
Hazardous Substance Spills to Tundra

Third Edition

Alaska Department of Environmental Conservation
Division of Spill Prevention and Response
Prevention and Emergency Response Program

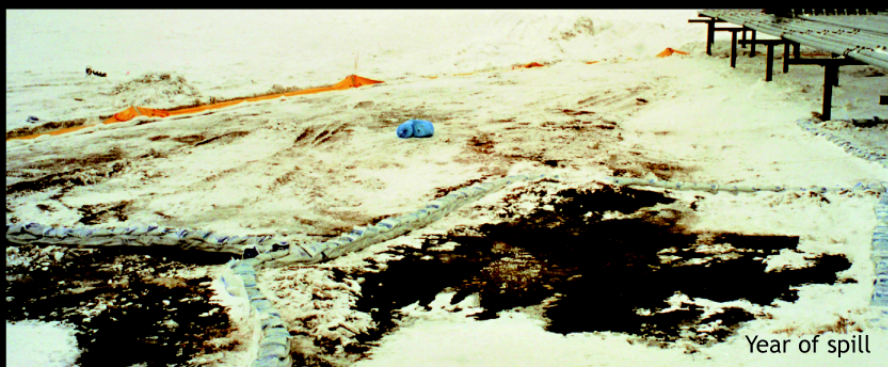
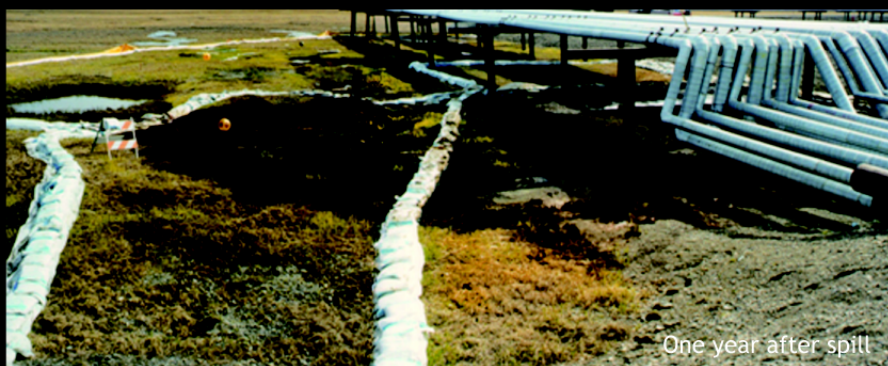
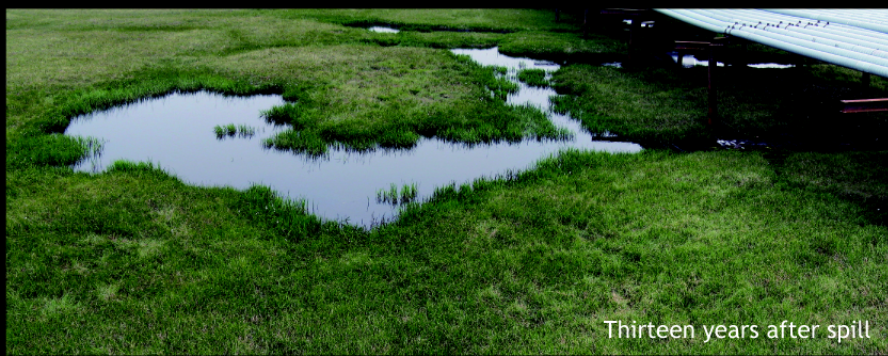
Drill Site 16, Prudhoe Bay Oilfield (top to bottom)

1. March 1997: A mixture of crude oil, methanol, and water affected 0.5 acre of tundra. Snow was used as an adsorbent, and the tundra surface was flooded and flushed with hot and warm water to melt contaminated ice and snow, and to recover contaminants.
2. June 1997: After the snow melted and the site was dewatered, propane torches were used to burn small areas of residual oil remaining on plants and on the soil surface. Fertilizer was applied to promote biodegradation and plant growth.
3. August 2009: After 13 growing seasons, indigenous plants have revegetated the affected area, giving it an appearance similar to the surrounding tundra. These plants originated from rootstock that survived the spill and cleanup operation.
